**State Bar of Arizona Task Force on Persons With Disabilities
Accessibility Committee Site Visit
City of Gilbert Justice and Municipal Court Facility
Phoenix, Arizona**

Facility: City of Gilbert Justice and Municipal Court, 55 E. Civic Center Drive, Gilbert, Arizona 85296

Date: April 16, 2004

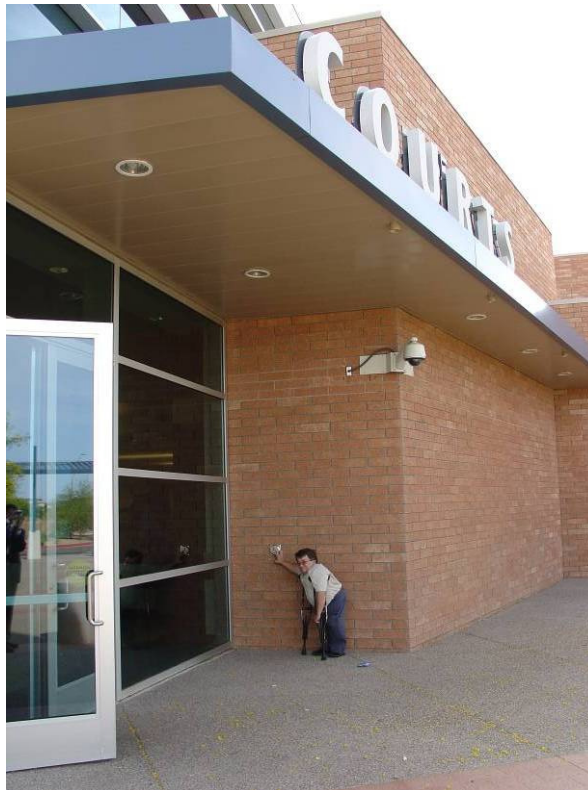
The main entryway is fully accessible. The entryway is very wide, and has considerable turnaround area for wheelchair users, along with extensive space to bypass security. The entryway has an automatic door opener button that is clearly marked and operated without incident. The distance between the door and the button is approximately ten feet, which is an appropriate distance to use the automated doors without rushing. The entry area is tile, which is very effective for persons using wheelchairs, but presents some risk for persons using canes or crutches. The entryway/security area is very large, with considerable area for alternate entry for “wandering” persons using wheelchairs.

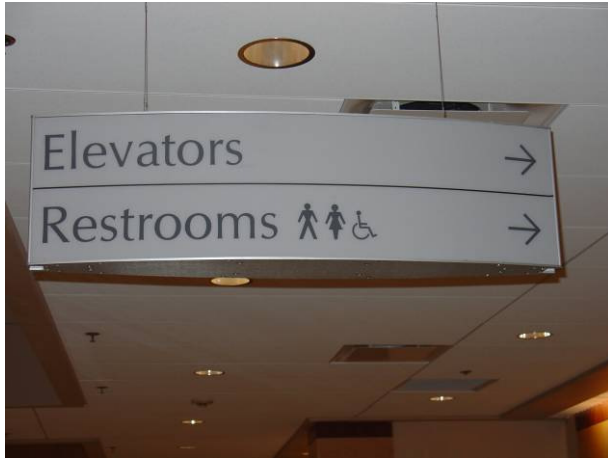
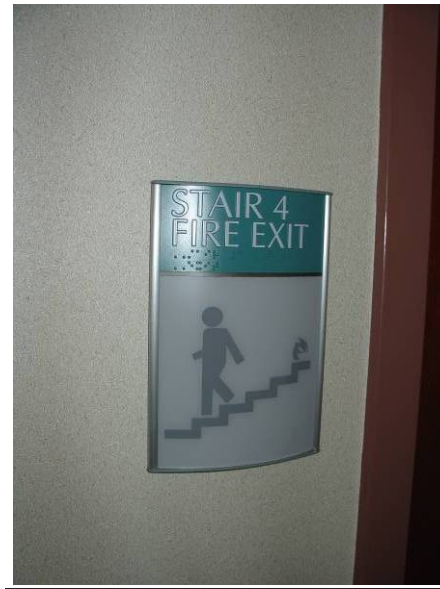
As with the entry, there was no problem with the exit. Interior exits were well lit. The stairwells are identified in universal signage, as both a stairwell and a Fire Exit, with Braille signage.

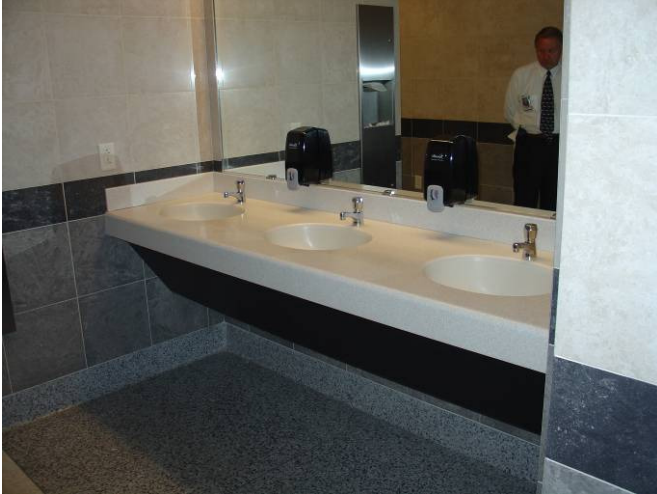
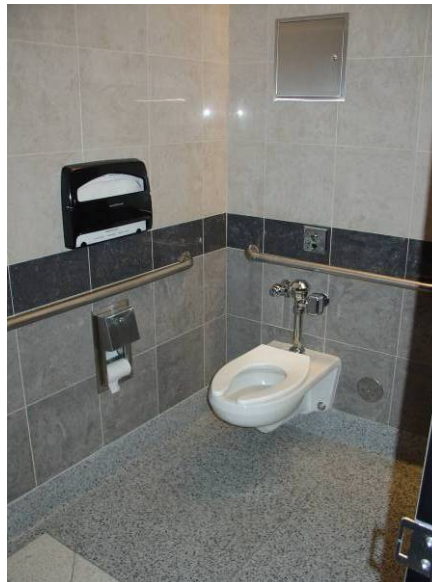
The locations of accessible restrooms were clearly marked, with universal signage. The faucets were plunge handles, that were relatively easy to operate. The soap dispensers were on the mirror, opposite the user. This survey has commonly suggested the placement of soap dispenser on side walls, making them easier to reach, but with the dispenser still over a portion of the sink to avoid spillage of soap on the floor, which could lead to unsafe, slippery conditions.

The sinks used a wood cover over the pipes, instead of pipe wraps, sloping down and away from the sink at a 45 degree angle. While this wood cover was common in courthouses in Maricopa County, the barrier makes it difficult for a person using a wheelchair to pull close to the sink. Otherwise, the sink is at an appropriate height.

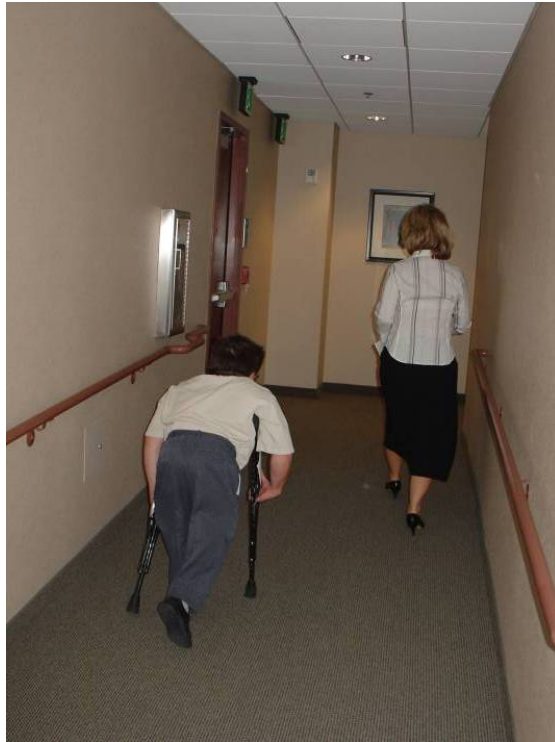
All hallways were wide. Employee hallways had ramps, with rails, including on a ground floor exit hallway. An employee hallway doorway was light tension, with no latches, and only grab bars instead.

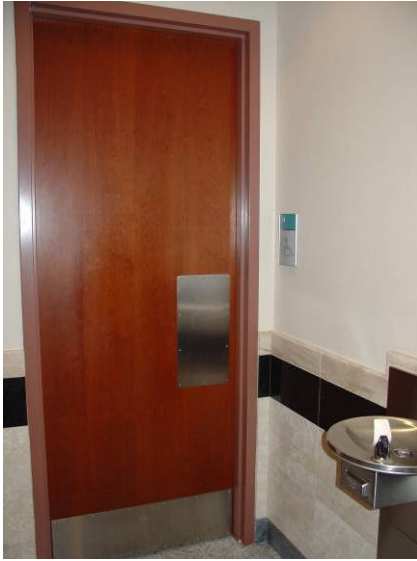
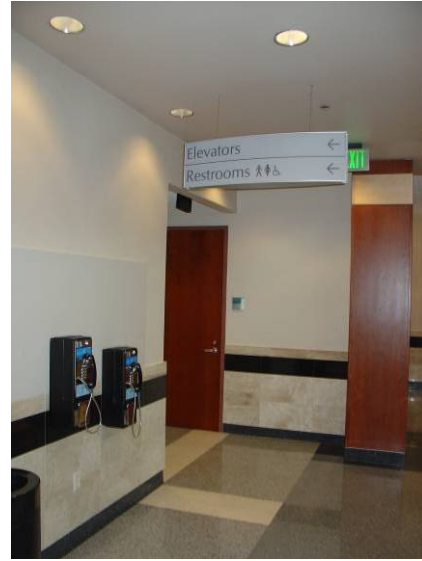
Each floor that the team observed had a public water fountain at wheelchair height, fully functional and easy to operate. Pay telephones in the hallways were at wheelchair height.

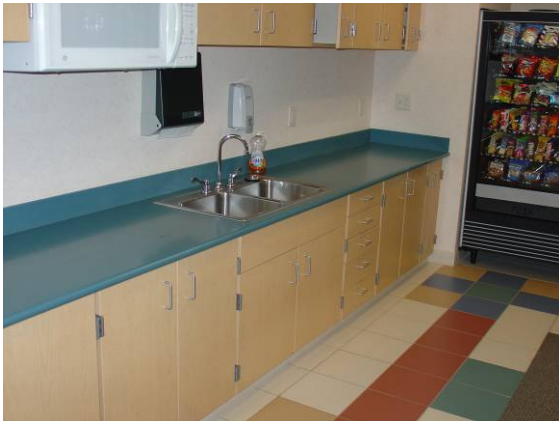
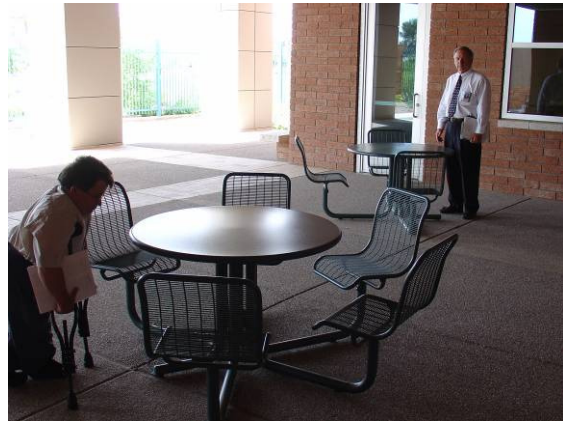
The employee lunchroom and break room was generally accessible, with wing handles at the sink. The outside patio area had accessible tables, with open space at the tables for wheelchairs. The patio also operated as an effective, close proximity fire exit.

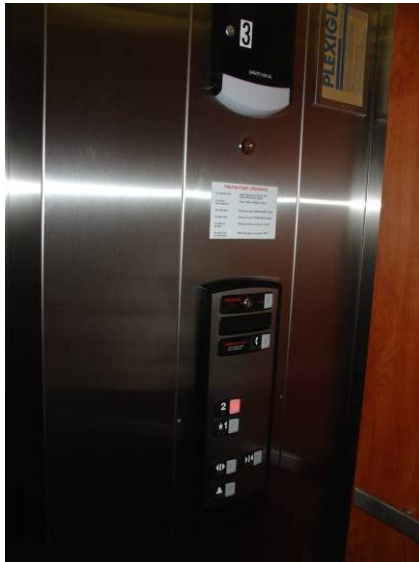
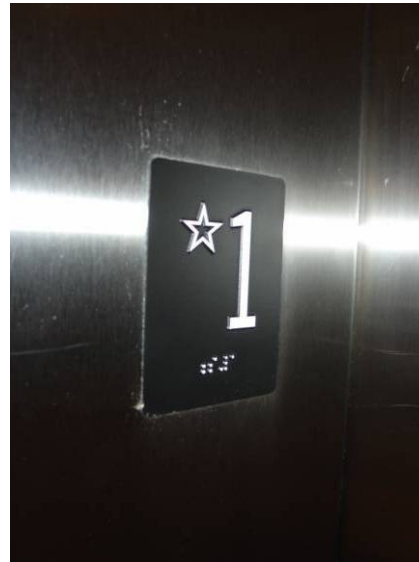
The elevator banks had Braille, completely universal signage, with an image of people in a box, with up and down arrows. There was sufficient room in the elevators for entry and mobility. The buttons were placed at appropriate heights. There is a "beep" at each floor as the elevator car arrives and the door opens. The metal casing outside each elevator had a bas relief numeral, with a star next to the "1" on the first floor, signifying the ground floor, and had Braille. The elevators had intercoms for emergency use and have rails at appropriate heights. The elevators are in all respects state of the art.

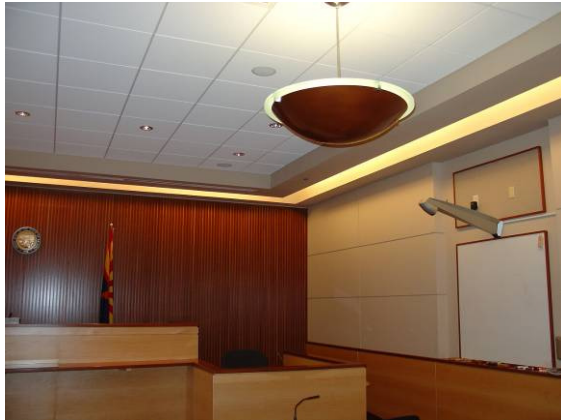
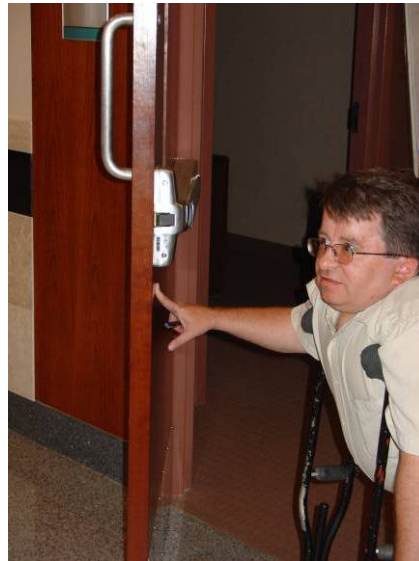
Courtrooms are located on floors one and two. The first courtroom the team viewed was **Municipal Courtroom 3**. Its exterior hallway sign was in Braille. The courtroom had three kinds of lighting: perimeter, continuous tube lighting, two large halogen, ceiling lamps, and spot lamp track lighting in the ceiling. The hallway doors into the courtroom swung open well beyond 90 degrees, which made the tension on them much more desirable than doors that reach their maximum opening at 90 degrees. The tension on the doors was reasonable, apparently somewhere between five and ten pounds. The hallway courtroom doors had a bar between the two doors for noise control, which could limit wheelchair passage space.

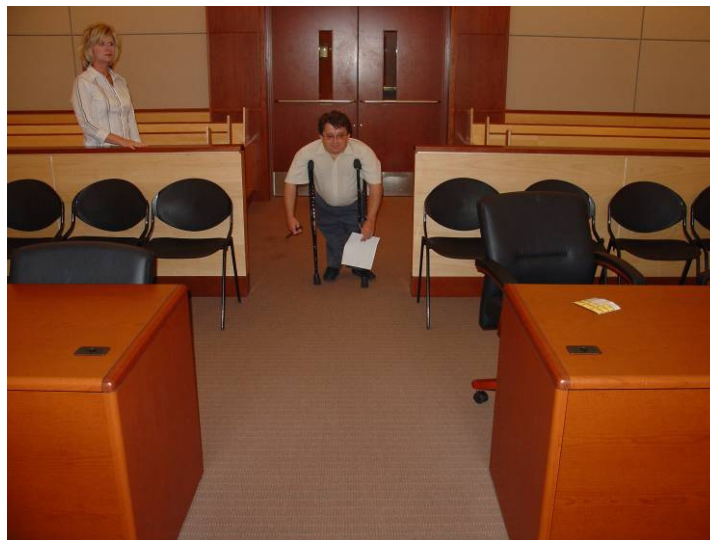
The passageway from the courtroom gallery for the public and the well of the courtroom did not have a swinging door, the absence of which is very beneficial to wheelchair users. The passageway appeared to be only approximately 36 inches wide. This is consistent with the width of the courtroom hallway doors.

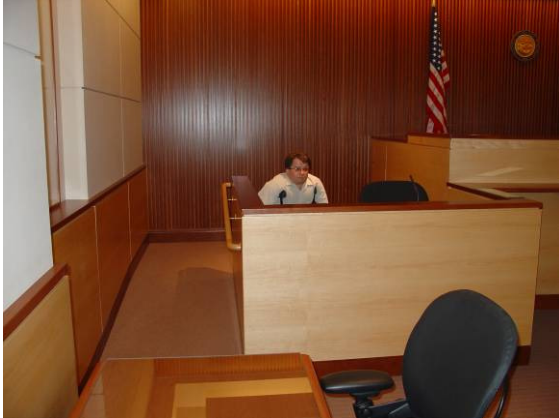
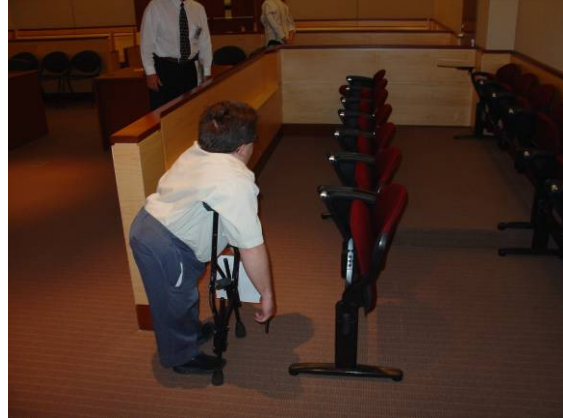
The witness box had an easy slope, with rails, at approximately 36 inches, making for a fully accessible witness box. The witness chair was on casters and therefore could be removed to accommodate a witness using a wheelchair.

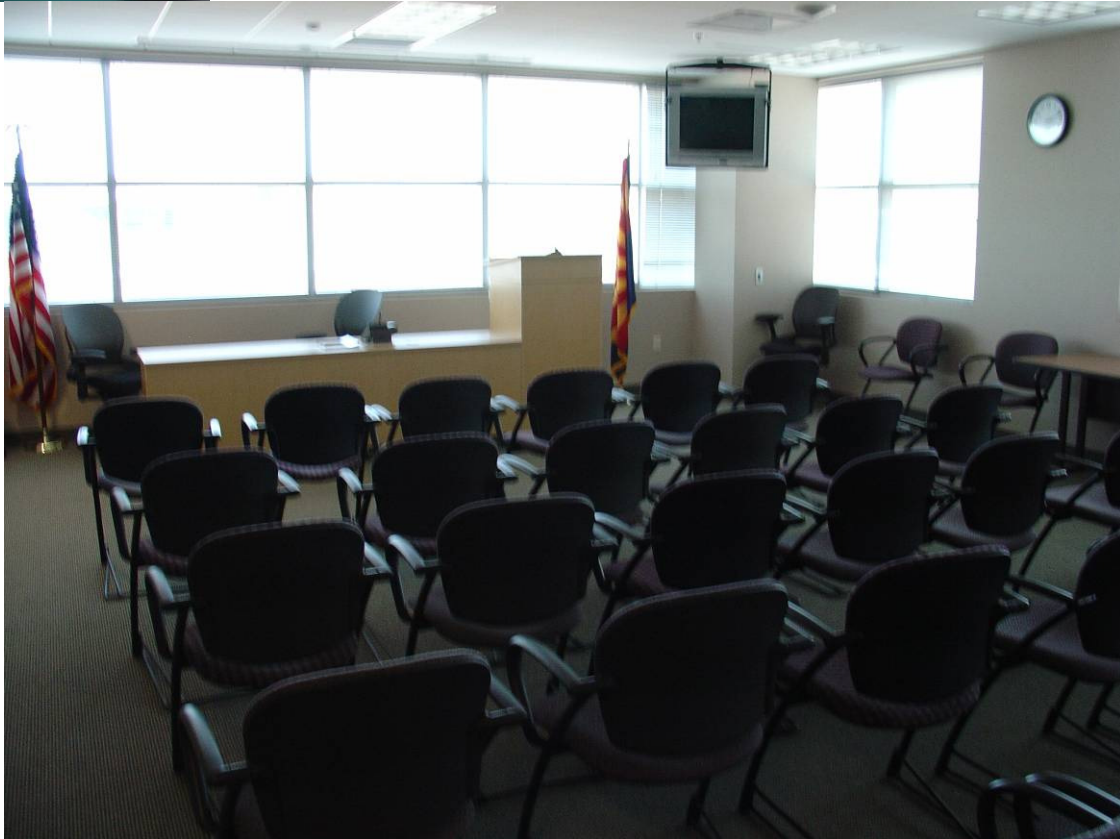
The Jury Assembly room was clearly marked with universal, Braille signage. The assembly room was fully accessible, with closed caption TV monitors. The Assembly room had fully accessible restrooms and accessible lockers.

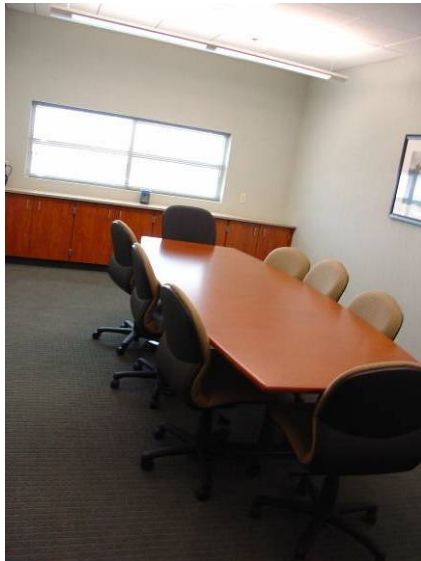
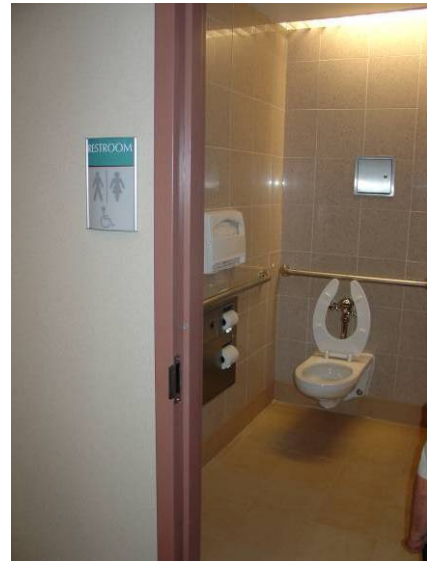
The team visited a municipal court jury deliberation room that appeared accessible in all material respects. The room was large, with easily removed caster chairs. The deliberation room had an accessible, unisex restroom, with universal signage and latch handles on both sides of the door. The room had interior grab bars, pipe wraps under the sink, and wing handles on the sink.

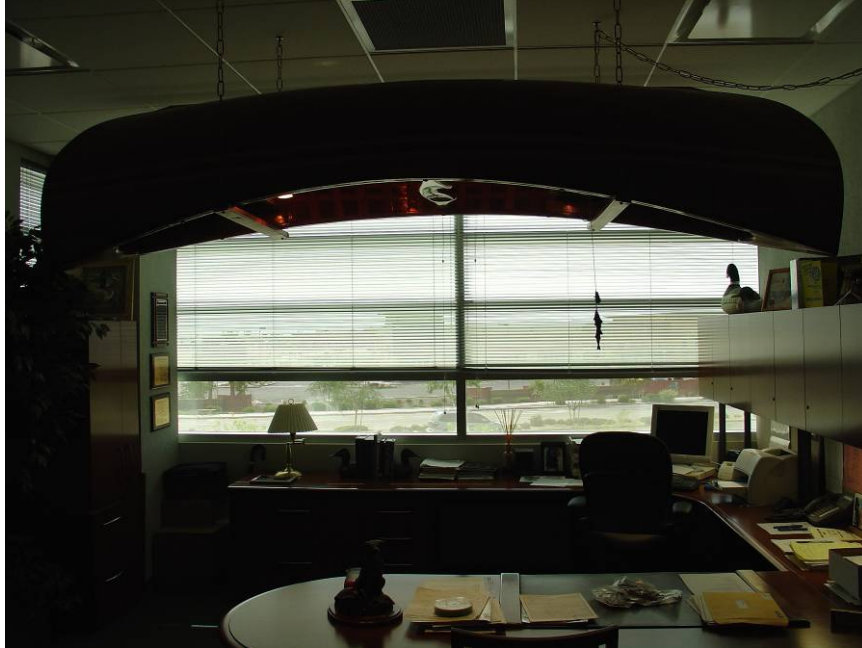
The team was afforded access to a representative chambers. There was ample room for any member of staff or visiting lawyer or member of the public to maneuver using a wheelchair or move with a walking device. There were no steps between the courtroom well and the chambers.
