**State Bar of Arizona Task Force on Persons With Disabilities
Accessibility Committee Site Visit
City of Phoenix Municipal Courthouse
Phoenix, Arizona**

Facility: City of Phoenix Municipal Court, 300 W. Washington, Phoenix, Arizona 85003-2103

Date: January 30, 2004

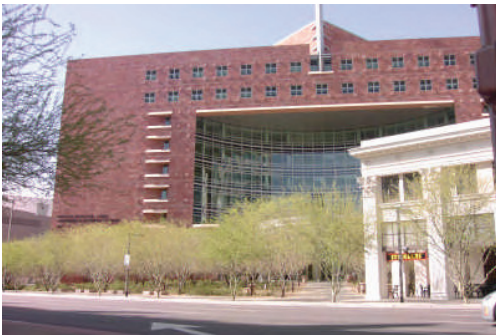
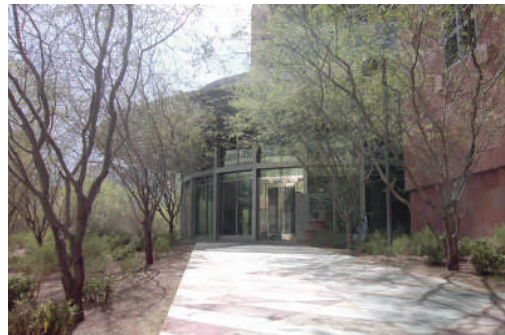
The facility faces south, with the main entrance and main parking on that side. The entryway had an incline pathway that was slightly challenging for manual wheelchair use.

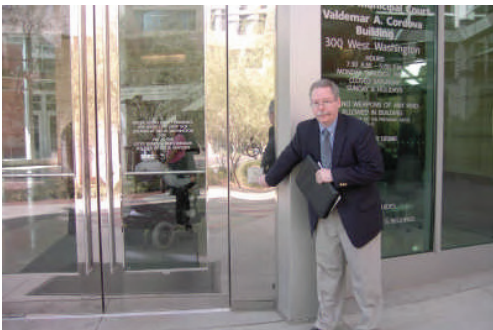
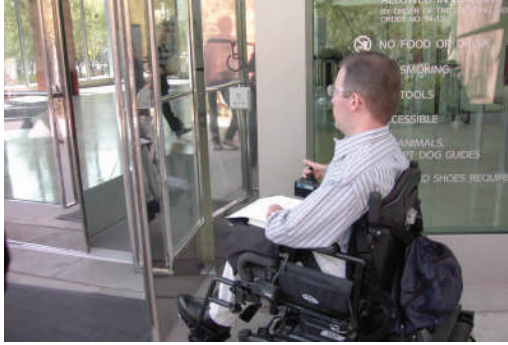
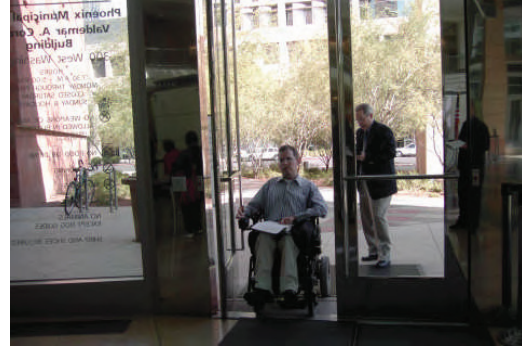
There was an automatic door opener button, but the position of the button required maneuvering around the door after pressing it because the door opened out (toward the individual). The timing of the automatic door opening and entry required more time than was available after pressing the button. Manual doors were somewhat heavy.

Suggestions: As it would most likely be cost prohibitive to alter the door to swing open away from the individual and into the courthouse, we suggest moving the position of the button and increasing the length of time the door remains open.

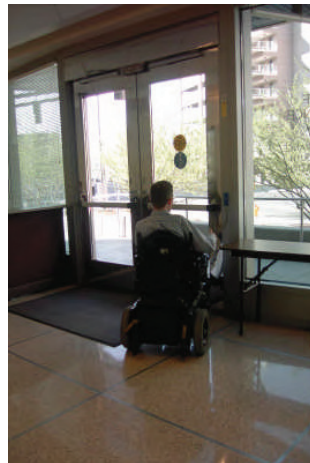
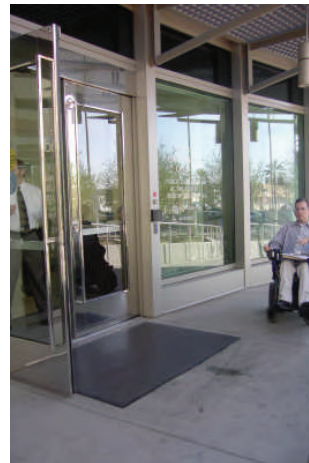
A side, employee entrance was fully ramped and accessible, with automatic, push button doors.

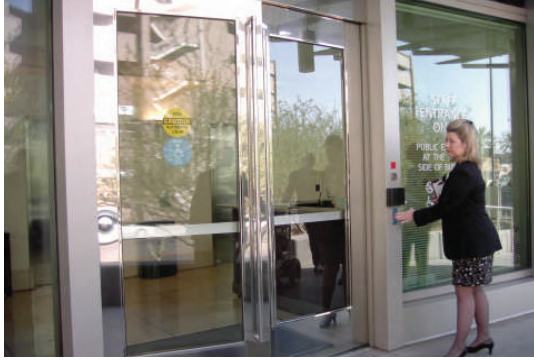
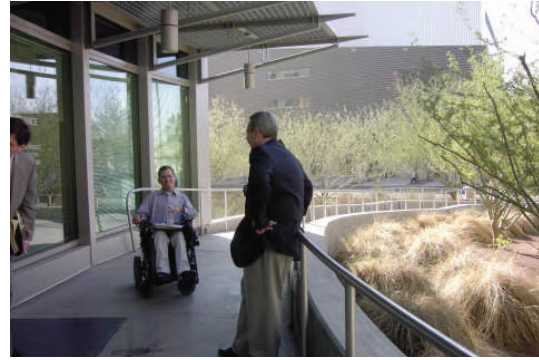
The railings on the ramp were at an appropriate height for a person using a wheelchair or with other mobility challenges to use.

Suggestion: At the employees' exit just inside the building, the "push to open" button appears high. Repositioning the button and moving a table which was positioned there would make this exit more accessible.

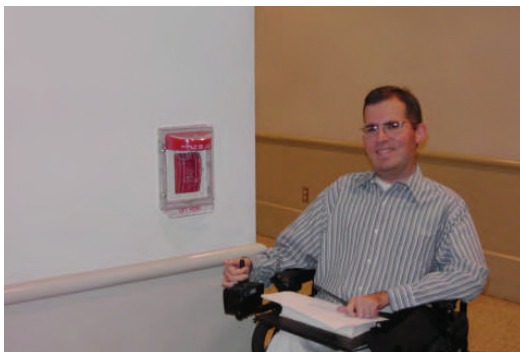
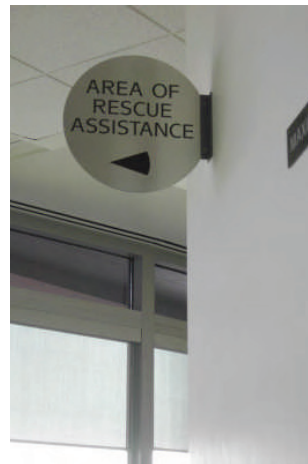
The main floor fire alarm lever was set at a low height for wheelchair users. There were prominently displayed overhead signs stating "Area of Rescue Assistance" designating points of refuge during evacuations.

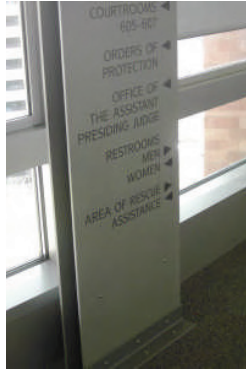
The main lobby sign menu included directions to a point of refuge. During an emergency, members of the public can gather at the top of the stairwells in each stairwell and on every floor. The staff inform the fire department personnel as to where persons with disabilities are in the stairwell. Evacuation plans are prominently posted on each floor.

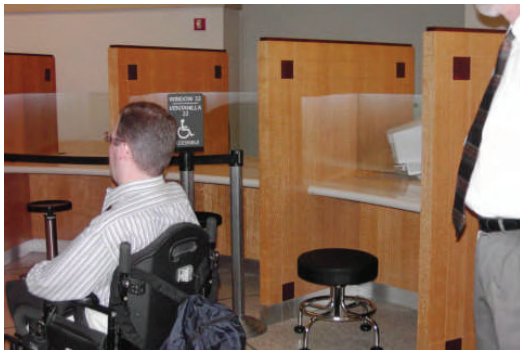
The Clerk's counter had low counter heights that were accessible to persons using a wheelchair. However, the payment kiosks and/or payment boxes were challenging for a person with limited upper body mobility to use, or height limitations, as the slot was located at the top of the kiosk.

Suggestion: If security factors would not be breached, moving the “payment slot” from the top to the front of the kiosk would alleviate an individual’s reach.

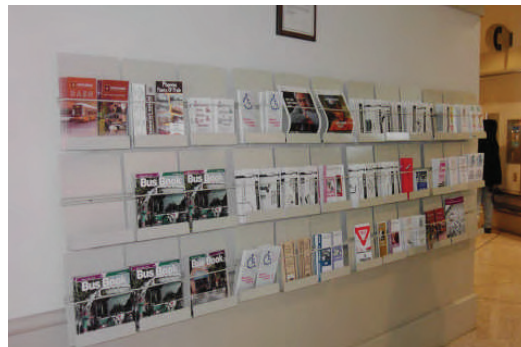
There is an extensive selection of pamphlets available, in both English and Spanish as well as in large print, describing services of the courthouse for members of the public, including for persons with disabilities. Interpreters provide their services to court defendants in over 44 languages and dialects. The informational display was prominent and extremely helpful.

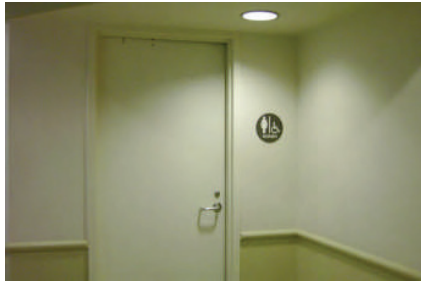
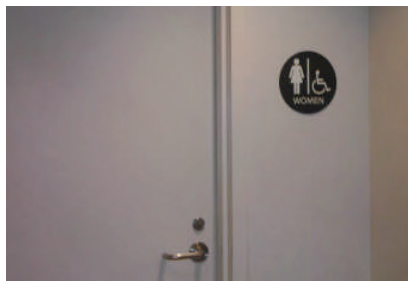
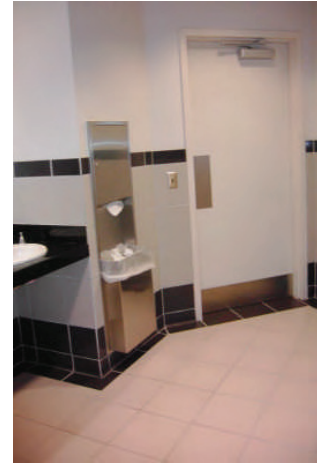
The team surveyed a representative sampling of restrooms in the courthouse, with an emphasis on the main floor restrooms. All restrooms seemed accessible with no significant issues or concerns noted. Proper signage with Braille and universal wheelchair indication were prevalent throughout the facility, particularly outside the restrooms. The restroom doors had accessible latch or “wing” handles, with some tension resistance that could pose a challenge for persons using a wheelchair.

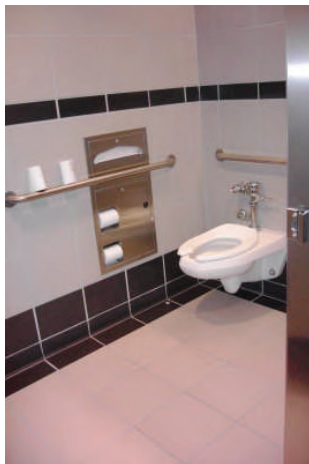
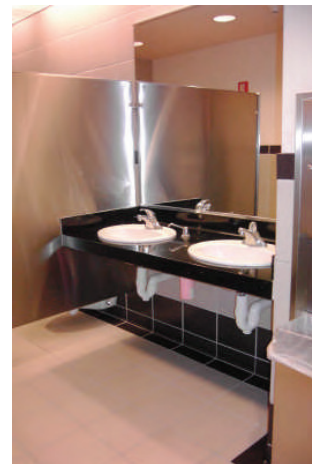
Each restroom had a fully accessible stall. The stall surveyed had full grab bars, and sufficient room in the stall to both transfer out of a wheelchair, and turn around in it, and keep it in the stall during use.

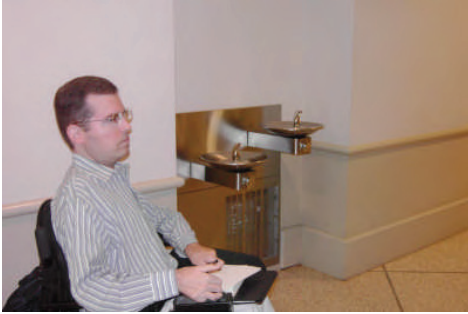
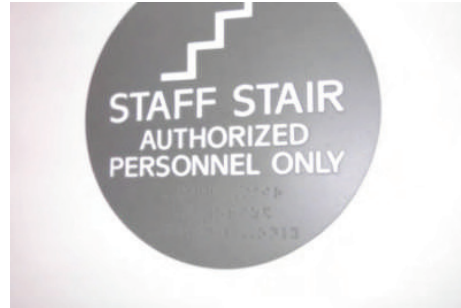
Each floor that the team observed had a water fountain at wheelchair height, with an easy-to-use, front push button. All were functional. Again, Braille signs appeared throughout the building.

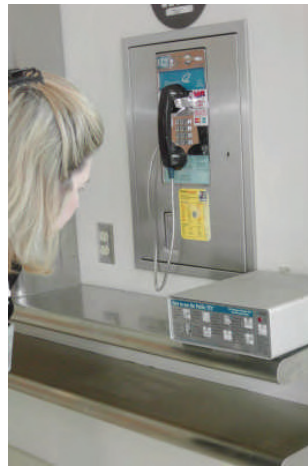
Braille, universal signage gave directions to a telephone that had TTY capacity. Pay telephones were clearly marked, with universal signage over each set of pay telephones. At each pay telephone bank, one of the phones was placed at a height for a person using a wheelchair.

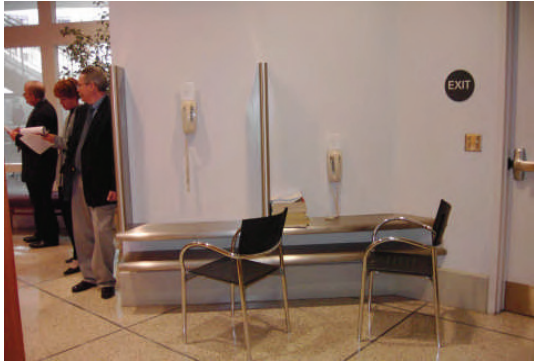
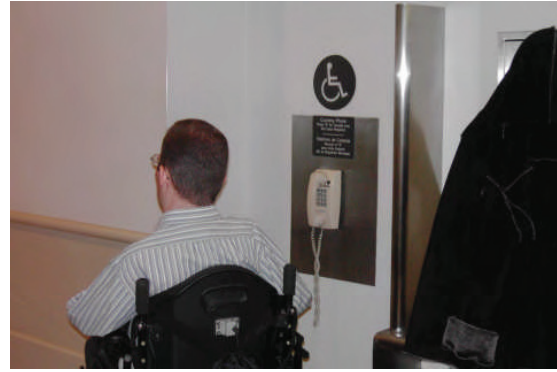
There was a free public phone, with outside lines, available for all members of the public, but with an accessibility sign above it. There were other public access, free phones in the building at low height for a person using a wheelchair.

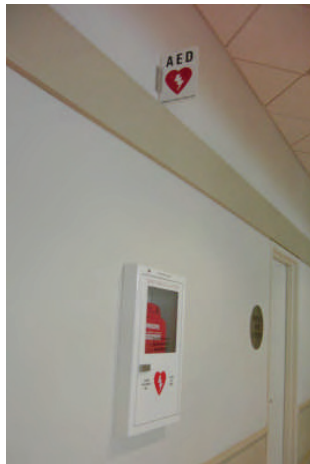
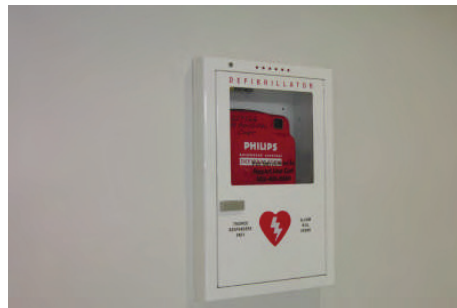
A heart defibrillator was prominently displayed on a lower level hallway wall.

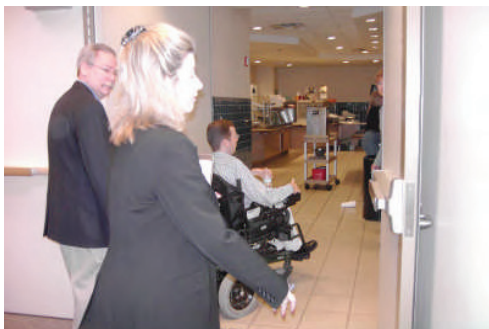
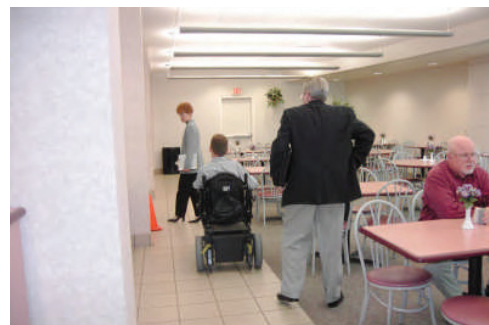
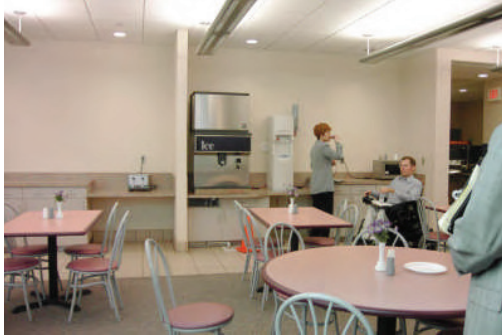
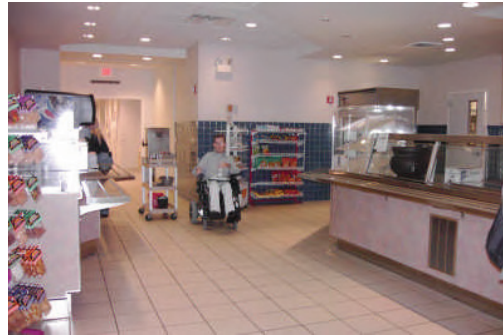
The team visited the cafeteria, which was accessible and possessed sufficiently wide passage and turn areas in both the food purchase and dining areas. The entry doors were accessible, with latch handles, and appear normally open. The kitchen appliances were low, with accessible counters, permitting a wheelchair to be wheeled up close to the appliance. A coffee machine in the middle of a passage was a slight impediment to a person using a wheelchair.

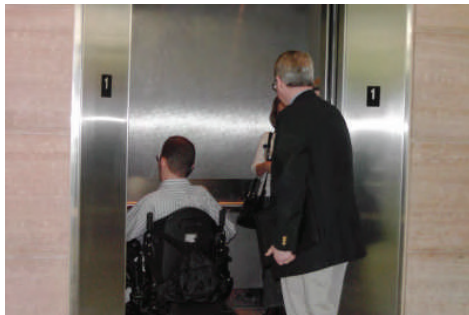
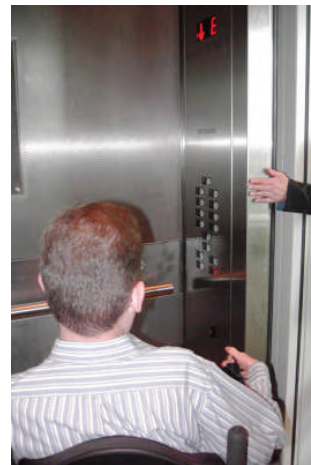
The public elevator shaft had sufficient room in the elevators for entry and mobility. The buttons were placed at appropriate heights, with a grab rail on the walls at mid-level. There is a "beep" at each floor as the elevator car arrives and the door opens.

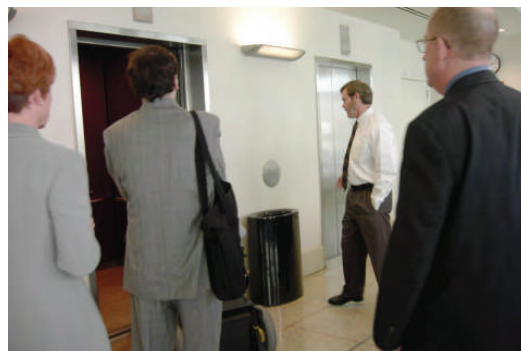
However, at an elevator bank in the interior of the building at the employee entrance, trash receptacles were located under the call button for the elevator, and hindered access by persons using a wheelchair.

Suggestion: Redirect the cleaning or maintenance personnel to station the receptacles away from elevator call buttons and doors.

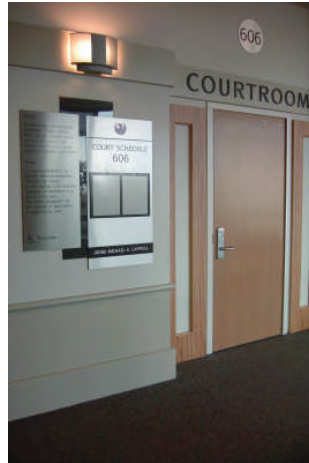
Courtrooms are located on several floors. The courtrooms are identified with metal accessibility signage, including instructions to the public that proceedings are recorded electronically.

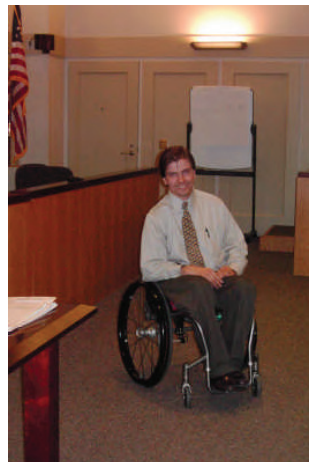
Interestingly, the team observed an attorney using a wheelchair in one of the courtrooms. He believed that the courthouse was generally accessible, but that the slope up to the main entrance was difficult to travel. There do not appear to be any simple answers to that issue.

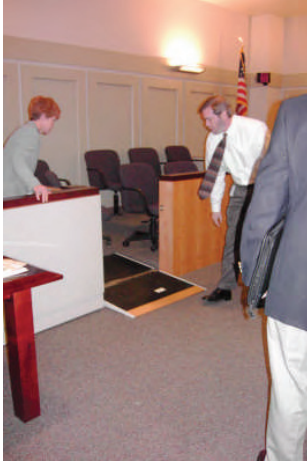
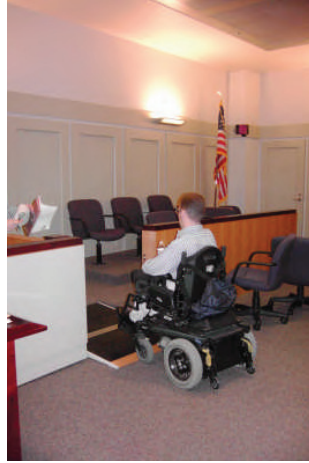
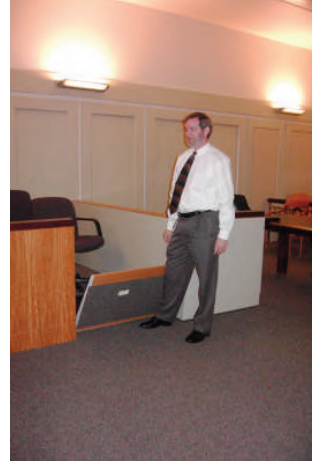
In the first courtroom visited, the jury box had an interesting, built-in ramp, which required assistance to open up for a person using a wheelchair to access the box. It was low cost, but it did require the assistance of someone other than the person using the wheelchair to gain access. The entryway into the jury box was wide enough for a team member using a standard size motorized wheelchair to enter, and the grade of slope was quite reasonable.

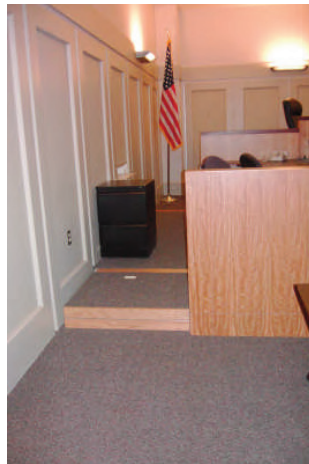
Once inside the jury box, there was sufficient room for a person using a wheelchair to turn around and fully participate in trial proceedings. The clerk/bailiff desk was also accessible via a fold-down ramp. These ramps, innovative and constructed at a reasonable cost, were the highlights of this facility with regard to accessibility.

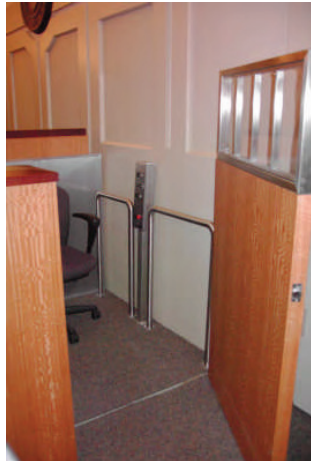
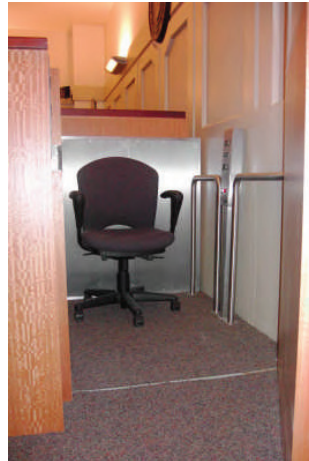
Uniquely, the courthouse had both “push handles” and “push bars” or “crash bars” throughout the facility. One of the courtrooms was specifically designed for a judge with a mobility disability, and had an operational lift to the bench.

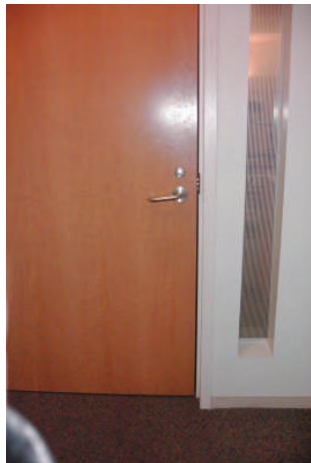
The courtroom doors were single doors, with an accessible latch handle, of somewhat strong tension. The doors would present some level of challenge to a person using a wheelchair.

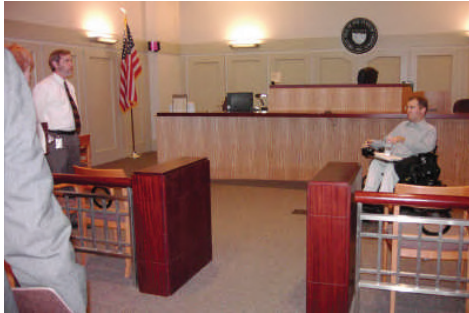
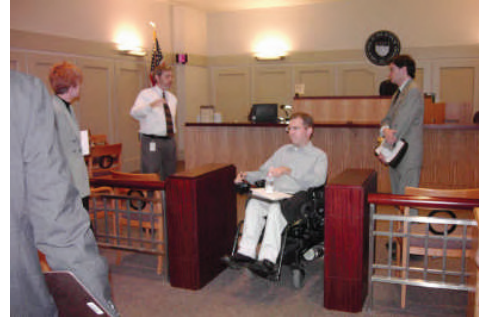
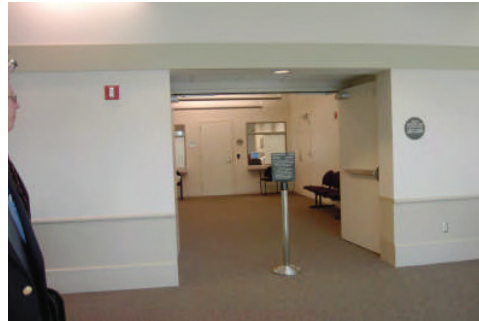
In the second courtroom visited, there was an open passageway from the gallery to the courtroom well, with a passageway that was fairly wide. The gallery area had sufficient space for several individuals using a wheelchair to observe court proceedings. The interior set of entry doors for the courtroom were glass paned push doors, with light tension and no lock bolts.

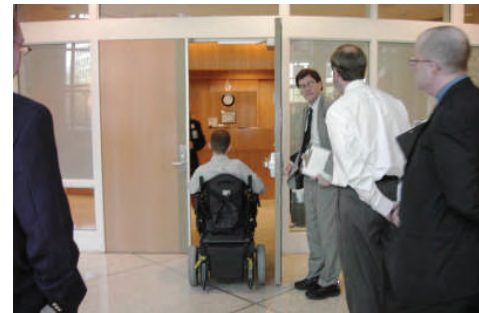
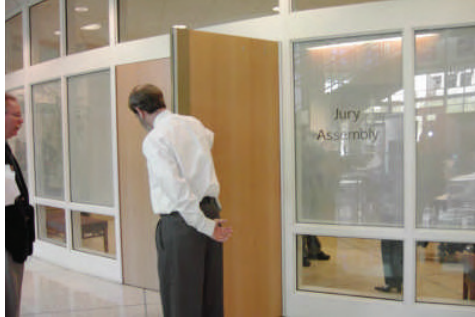
The jury assembly room is on the first floor and is entirely accessible if the doors are open. Otherwise, the entry doors to the assembly room have a slightly high tension and are challenging to use. They have crash bars for exit out into the lobby, which are generally preferable for persons using a wheelchair. There is no middle post between the entry doors, again, which is good.

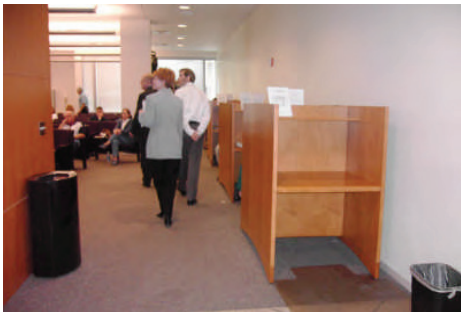
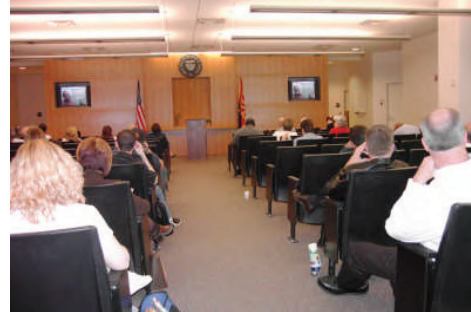
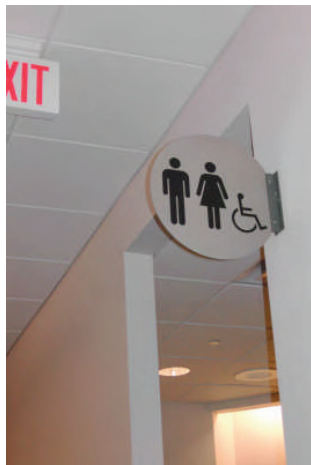
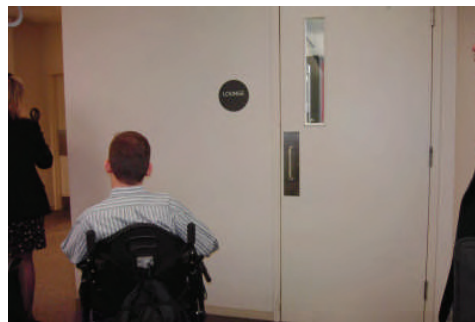
There is easy access for a person using a wheelchair and also for any other device used to assist mobility within the assembly room. There are television monitors inside the jury assembly room, which are used, in part, for informational purposes. It was believed, but not confirmed, that the monitors all had close caption capacity.

Jurors are provided with keyed storage lockers and some were installed at low heights with special handles. Several rollup workstations were located at the back of the room.

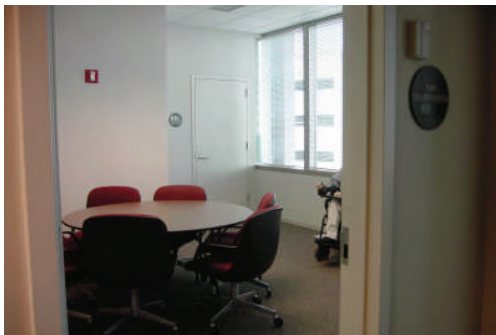
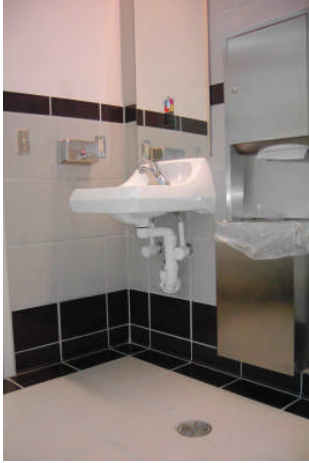
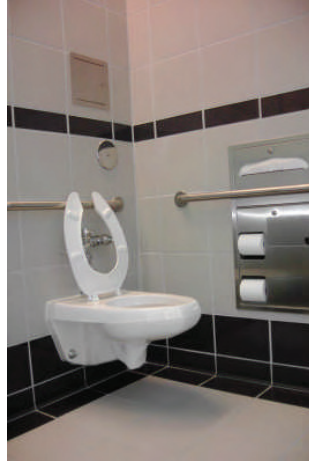
The jury deliberation room that the team visited was accessible, with wing handles on the interior bathroom door and accessible signage. The bathroom had heat wraps on the pipes and a soap dispenser optimally placed to the side of the sink. The toilet was fully accessible, with surrounding grab bars. The deliberation table was one that a wheelchair could move around relatively easily.

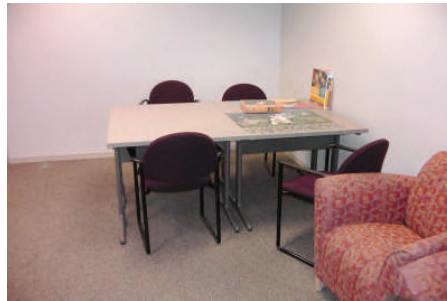
The Jury Center included a separate reading room. The door closed quickly and was heavy, but a minor readjustment to the door tension would alleviate this issue.
