**State Bar of Arizona Task Force on Persons With Disabilities  
Accessibility Committee Site Visit  
City of Scottsdale Justice Court Facility  
Scottsdale, Arizona**

**Facility:** City of Scottsdale Justice Court, address, Scottsdale Arizona

**Date:** April 23, 2004

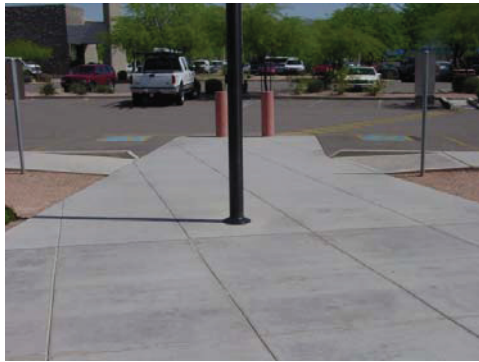
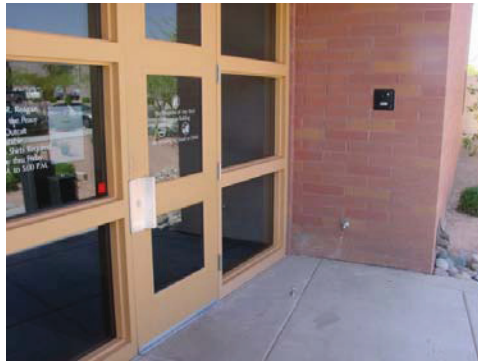
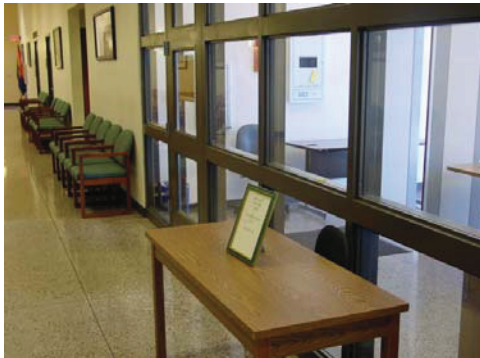
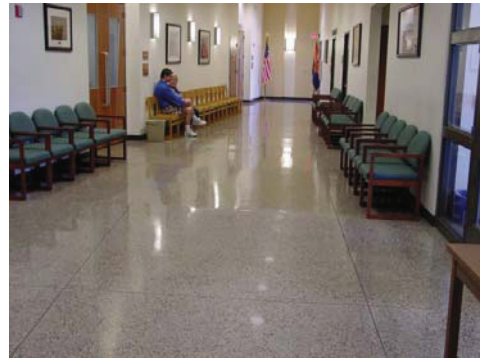
The main entrance did not have an automatic door opener. The tile floors are extremely convenient for persons using a wheelchair, but could present a potentially slick surface for persons with canes or crutches, under circumstances not present when the team visited, such as spilled liquids, etc. “Roughed up” tiles surfaces present a safe, accessible compromise.

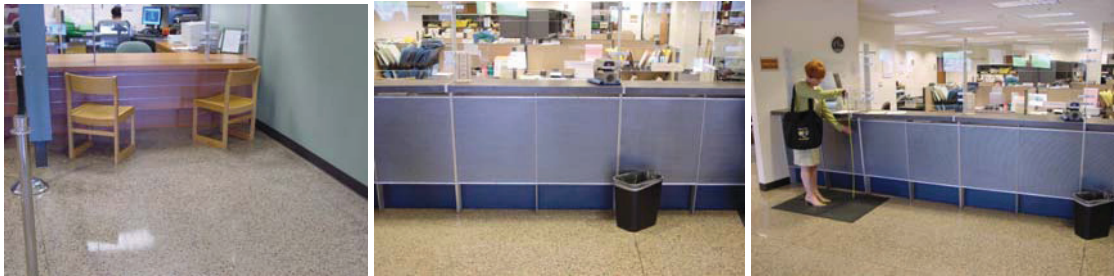
The Clerk's Counter had a special, accessible counter height with removable chair for persons using a wheelchair or scooter.

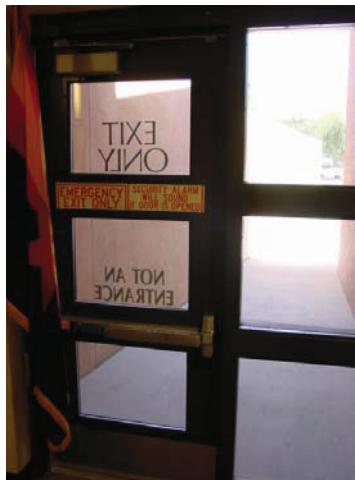
The emergency exit had a crash bar door, which is preferable to a door handle, either knob or latch.

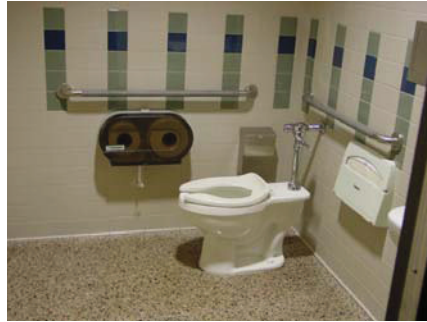
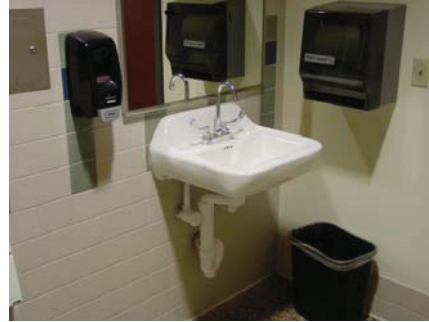
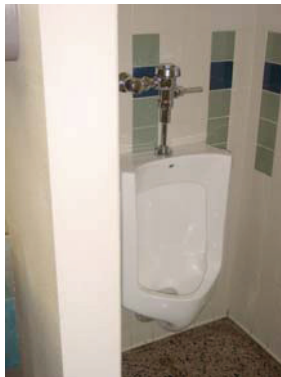
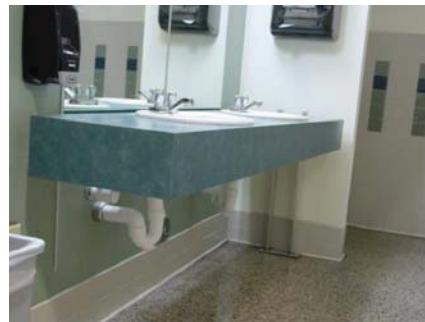
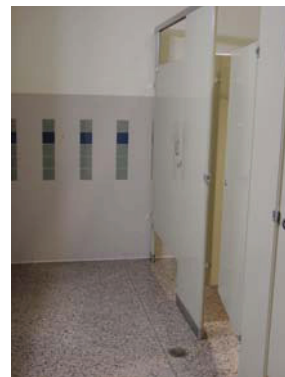
The team surveyed the restrooms in the courthouse on the main floor and in the jury deliberation room. All restrooms seemed accessible with no significant issues or concerns noted. For male restrooms, this included a urinal at lower height, important for users of wheelchairs. The accessible stalls were extremely large and convenient. The counters were accessible with appropriate pipe wraps. Placement of soap dispensers is a consideration upon any remodeling, with our recommendation of sidewall placement to permit persons using wheelchairs or with low height, to reach the dispensers without excess soap materials falling on the floor and creating

slippery surfaces. A second towel dispenser over the trash dispenser was easily used, which offset that the counter dispenser was slightly high for a person using a wheelchair.

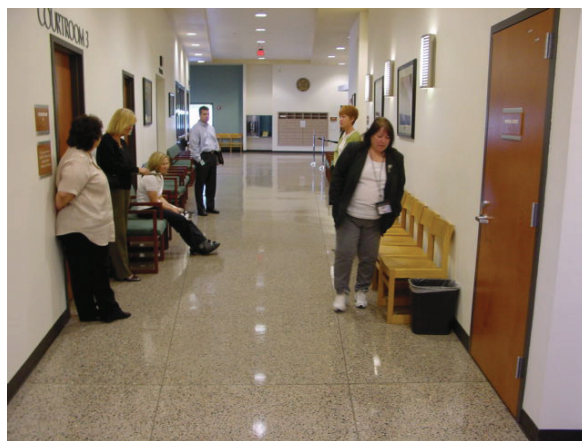
All hallways were very wide, with many chairs. The court staff area was very functional for employees with disabilities.

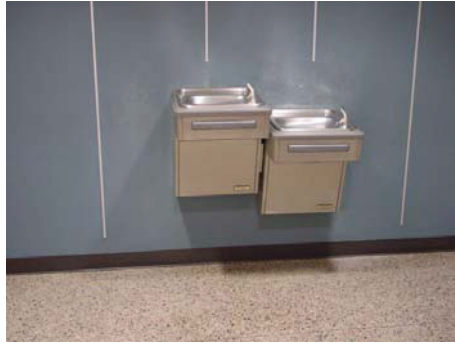
The water fountains were at wheelchair height, and were functional.

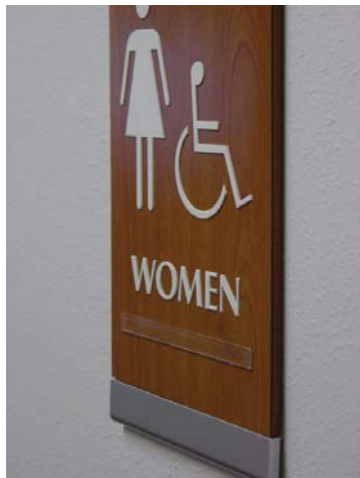
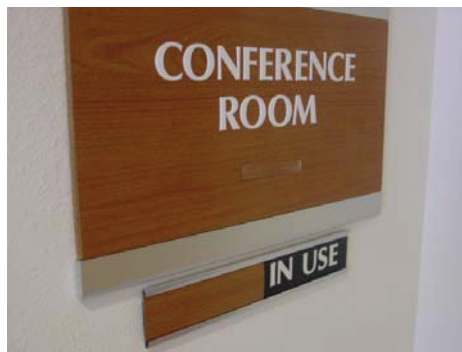
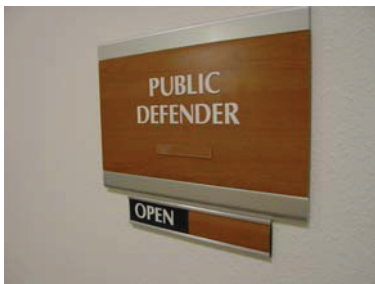
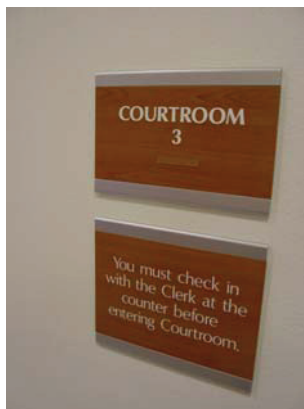
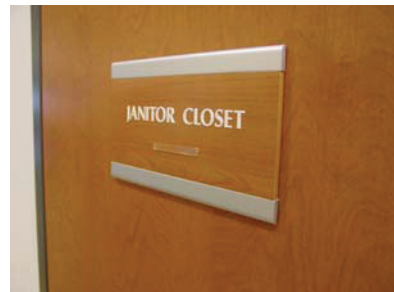
Braille signage was observed throughout the structure. Even the janitor's closet had Braille signage.

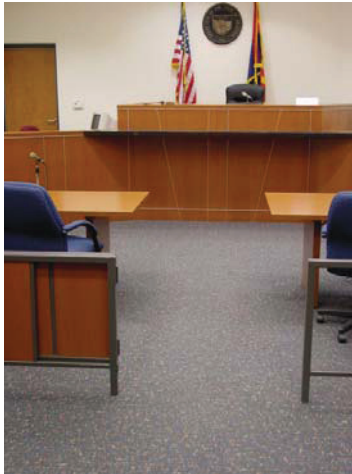
### Courtroom facilities

Both courtrooms are located on the ground floor in this single-story building. The courtrooms are very accessible to members of the judiciary and public. The courtroom design is one of the best observed, particularly for a justice court. A ramp leads to the witness stand, and jury box, with a wall and railing on the “well side” of the ramp. While the well-side retainer wall made the ramp safe from falls, it had a limited width, posing passability challenges for some wheelchairs.

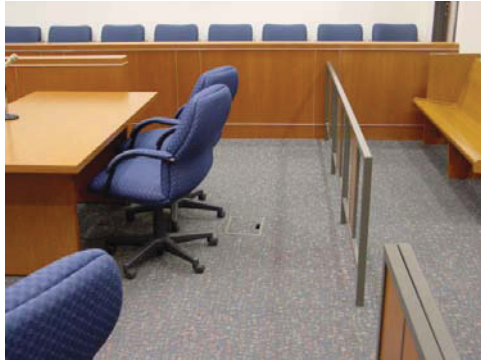
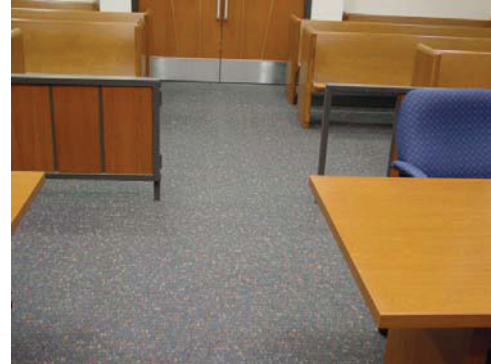
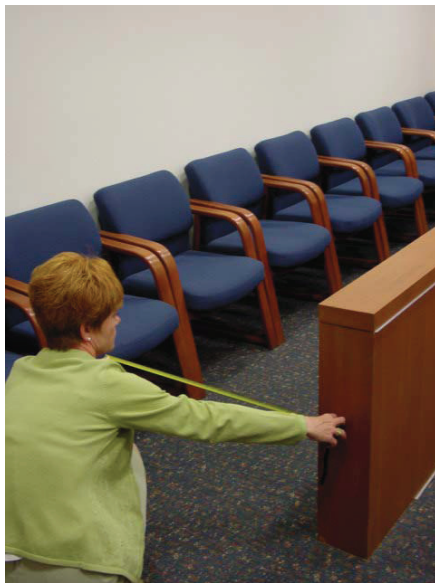
There was no swinging gate separating the public gallery from the courtroom well, the absence of which is more convenient for persons with mobility challenges. The jury box had only removable chairs, which would easily accommodate a wheelchair. The witness box had a removable chair, which accommodated wheelchairs.

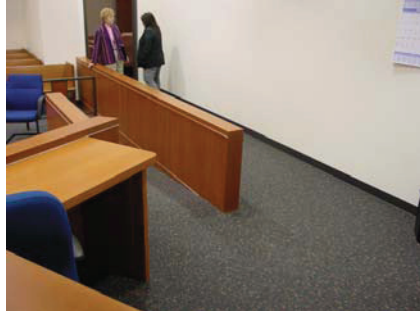
The two courtrooms share a single wall, and are mirror opposite configurations. This permits both courtrooms to use the same jury deliberation room. The deliberation room is fully accessible, as is its restroom.

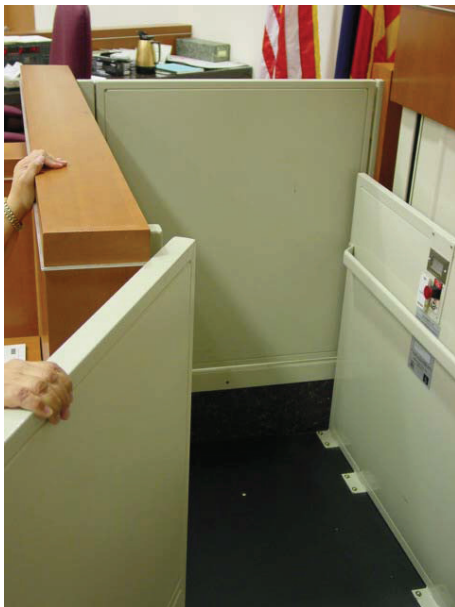
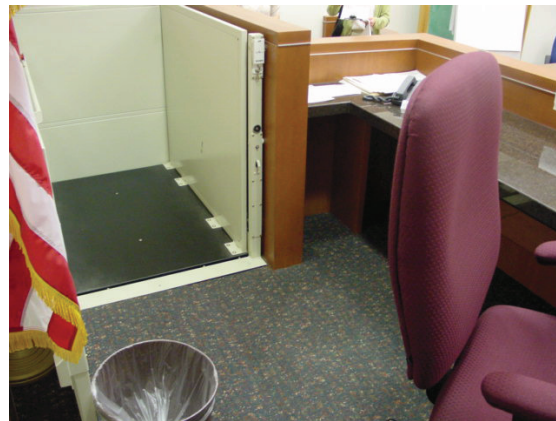
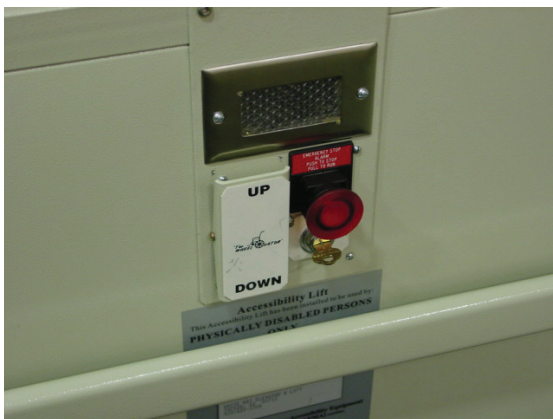
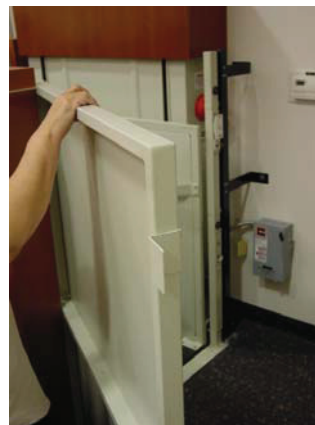
Remarkably, the Judge's benches in both courtrooms had fully-automated wheelchair lifts. They functioned well upon testing.

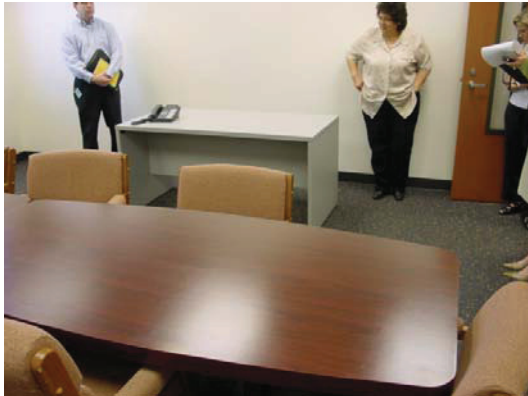
The jury assembly room is accessible via a ramp, with accessible latch handles. The bathroom inside was very accessible, with a sink with appropriate pipe wraps, and easily accessible soap and towel dispensers. The assembly table was surrounded by caster chairs, easily moved for persons with mobility challenges.

There are television monitors inside the jury assembly room, which are used, in part, for informational purposes. The jury restroom was fully accessible.
