**State Bar of Arizona Task Force on Persons with Disabilities
Accessibility Committee Site Visit
Pinal County Superior Court (prior facility)
Florence, Arizona**

Facility: Pinal County Superior Court, 31 N. Pinal Street, Building E, Florence, AZ 85232
(520) 866-6317

Date: October 10, 2003

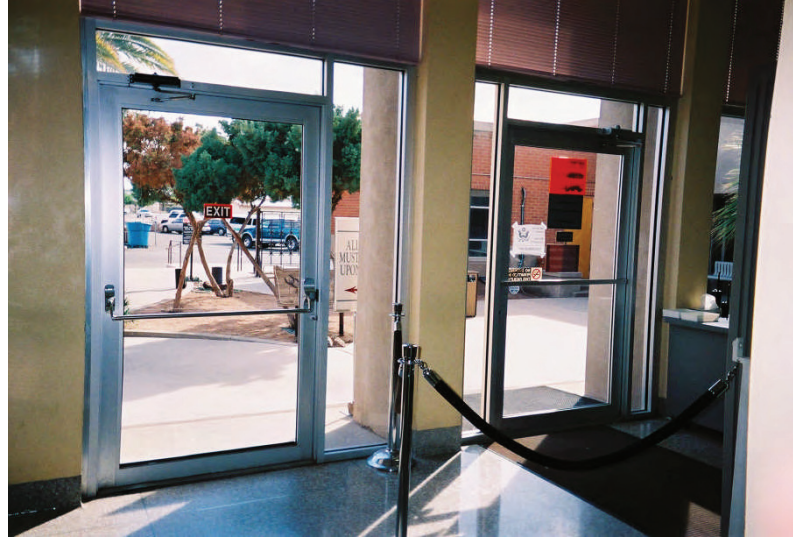
The main entrance to the courthouse on Pinal Street is easily accessible by a wide well marked ramp and entry door. The emergency exit in the rear of the building also provides a marked ramp for access; however, the emergency exit does not provide blinking identifying lights for the auditory disabilities or Braille markings for the blind.

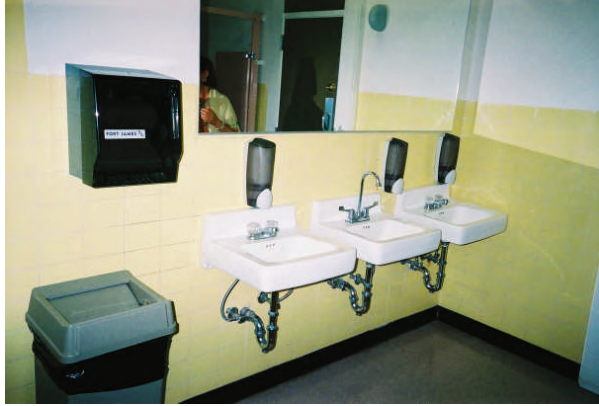
The courthouse provides two men's and two women's restrooms. One set of restrooms has been reconfigured and is accessible, however, the paper towel and soap dispenser in the accessible restrooms are mounted too high above the floor for easy access. One sink also has flip knobs making it difficult to turn the water on and off. A recommendation was made to put signage by the inaccessible restrooms directing users to the accessible restrooms.

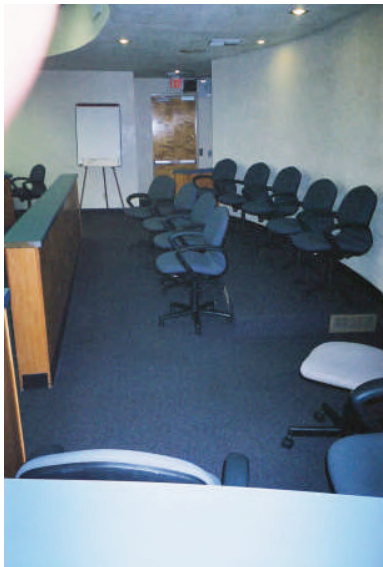
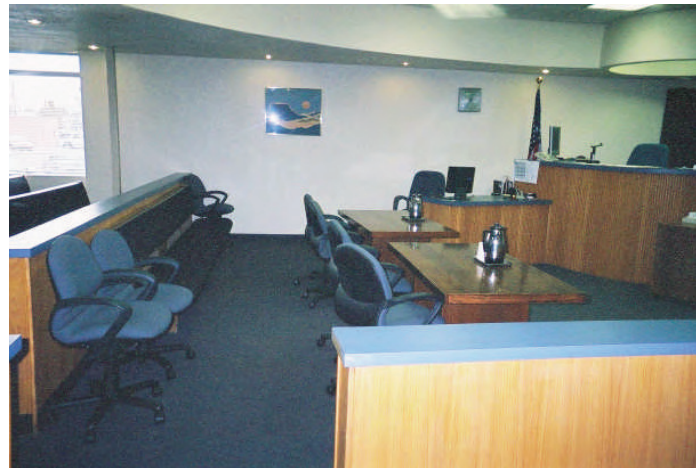
Courtroom 3:

The courthouse has six courtrooms, one of which is accessible. Division Room 3 is completely accessible providing full access for the judge, jury, counsel, and witnesses. There is ample room in the gallery and emergency exit access is good.

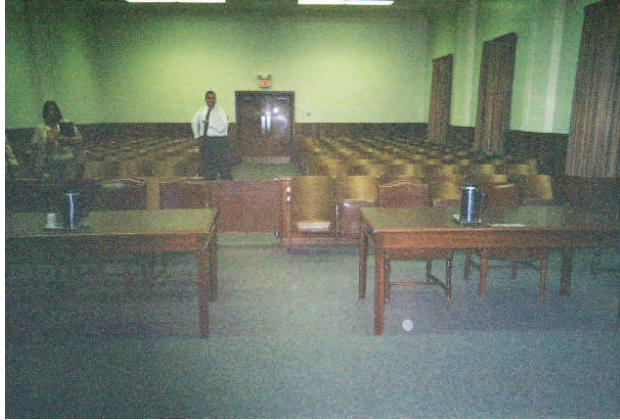
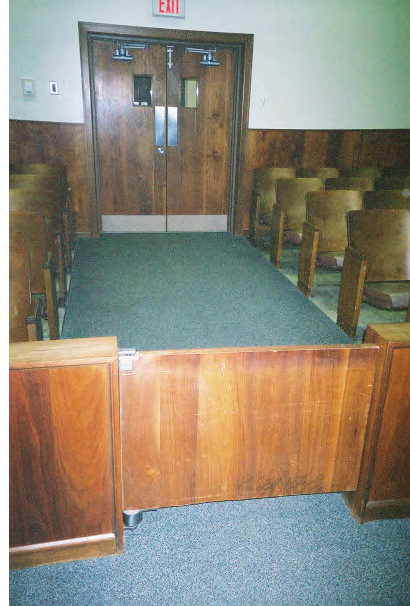
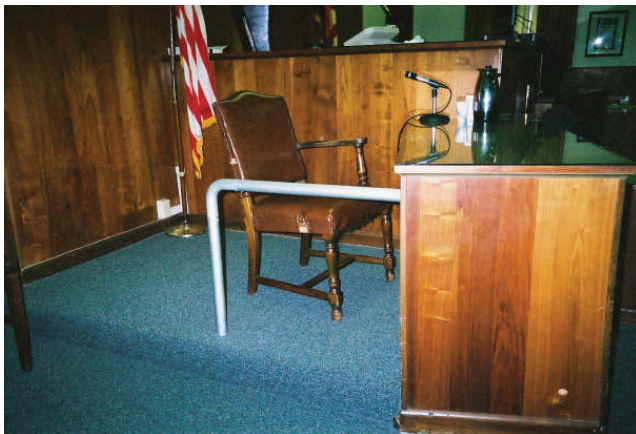
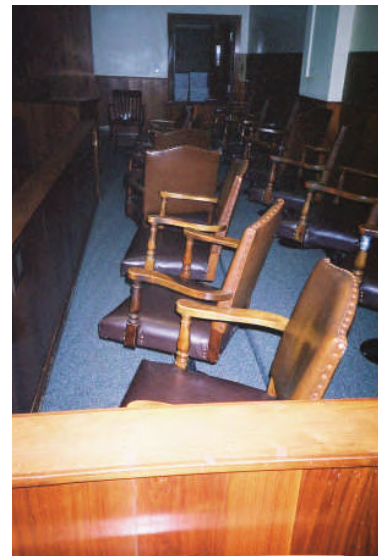
All other courtrooms have many steps and other impediments to persons with disabilities including raised jury boxes, judge's benches, clerk's boxes and witness stands. The oldest and largest courtroom presented obstacles to accessibility to be expected in more traditional, historic courtrooms, such as elevated jury boxes and witness stand, without any form of ramp.

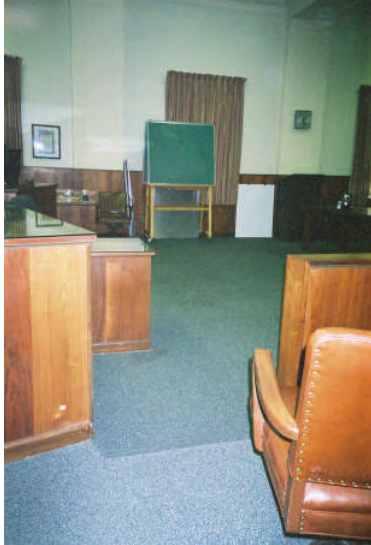
Fixed chairs consistently presented obstacles to accessible seating, whether within jury boxes or in the gallery. One of the courtrooms had a gallery passageway with an extremely narrow pass-through. Otherwise, once inside the courtroom "well," there was a great deal of room for mobility with any kind of walking assistance or wheelchair. Consistently, older courtrooms seemed to present very large courtroom wells, which occasionally presented very good opportunities for accessible retrofits, such as ramps into the jury boxes or witness stand.
